**NUMBER:** 08-019-17 REV. A

RG3 RG4 RJ3 RJ4 Radio Enhancements

This bulletin involves inspecting and if required, updating the radio software.

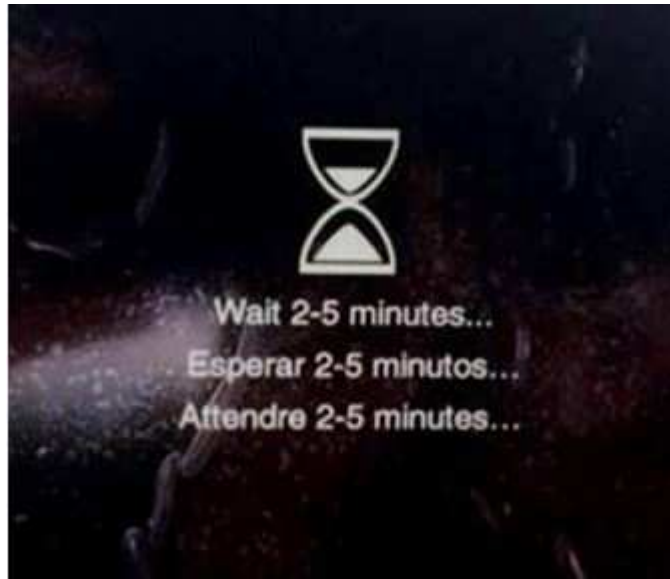
Fig. 3  
Hourglass Screen

**NOTE: \*\*During the update process you will see multiple hourglass and “Please Insert Update USB” screens for extended periods of time (several minutes) (Fig. 3) or (Fig. 4) . DO NOT remove the USB flash drive at this time. Only remove the USB flash drive when the update has completed, when the screen displays the software levels again. The screen will say “Software updated successfully”.\*\***

**NOTE: During the update process, the screen on the radio will display an hourglass and blue screen that said "Please Insert Update USB" for approximately two to five minutes at a time ([Fig. 3](#)) and ([Fig. 4](#)) .**
