NUMBER: 08-068-20 REV. A

GROUP: 08 - Electrical

UGQ Radio Enhancements

2019 - ****2020**** (MP) Jeep Compass

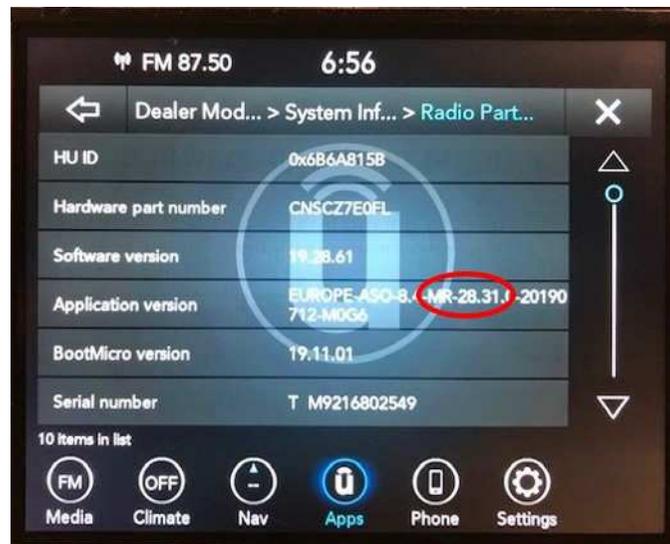
Fig. 1

Radio Software Level Screen

1. Verify the radio software version. Radio must be in Dealer Mode to verify by following these steps:
 - a. Press and hold both lower corners of the display screen, until the Dealer Mode screen appears (approximately seven seconds). Release screen.
 - b. Select "Radio Part Information". The software version will be listed next to "Application Version" (Fig. 1) .

2. Is the radio software level (Application Version) at or higher than 34.21?
 - YES >>> The radio software is already up to date. Normal diagnostics should be performed.
 - NO >>> Proceed to [Step 1](#) of the Repair Procedure.

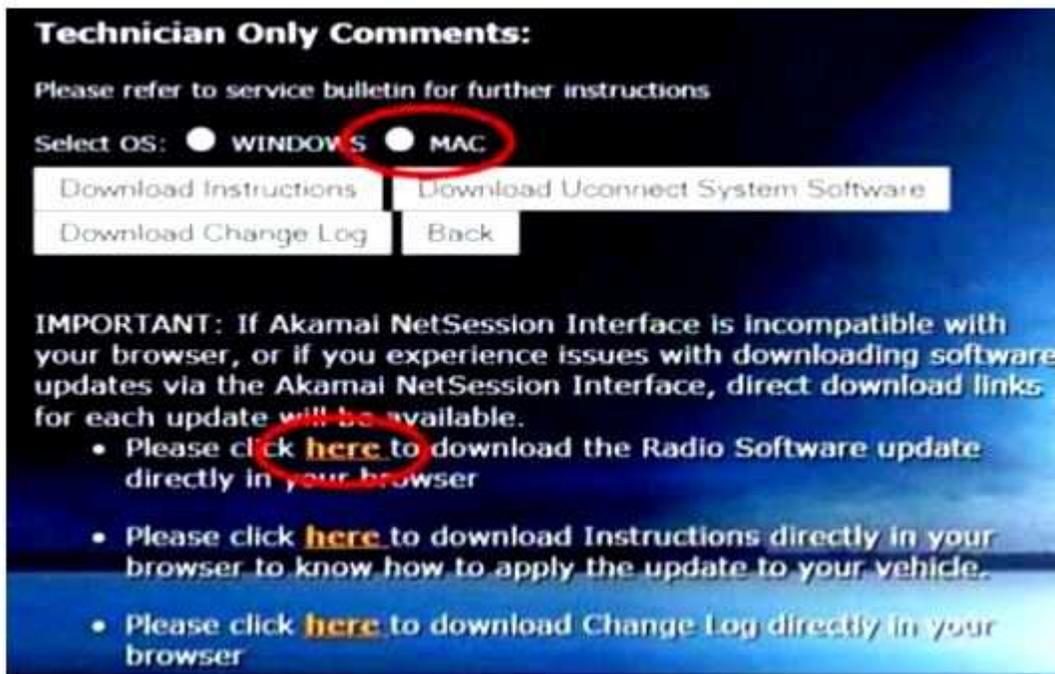
Fig. 3

MAC Download Steps

5. Download the software update file to your local PC's desktop. Make sure to select the "MAC" radial button for all downloads (Fig. 3) .

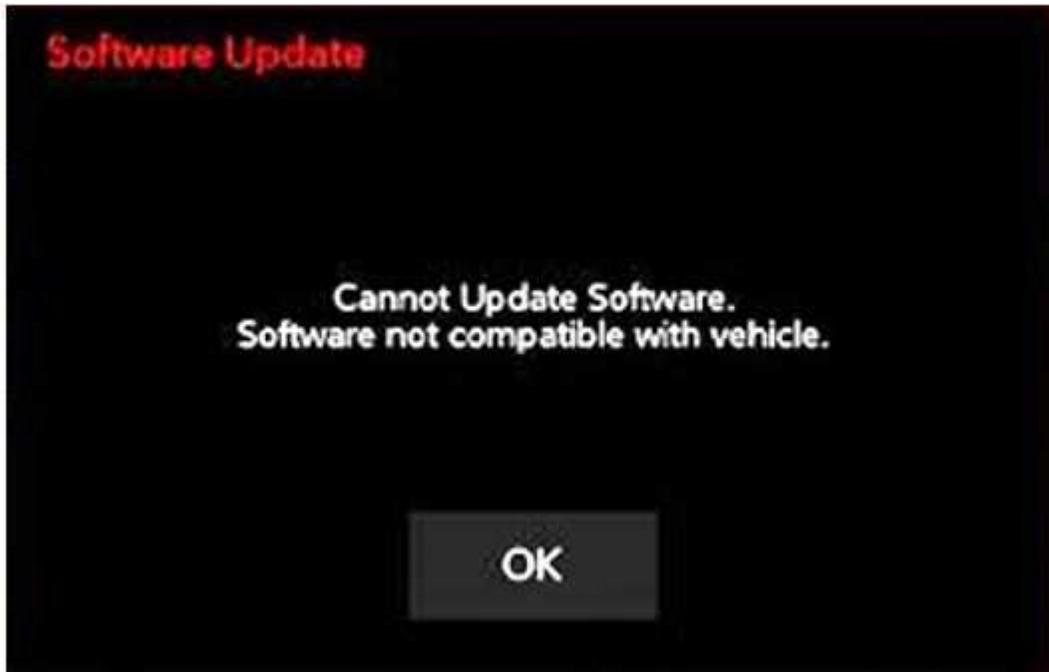
Fig. 5

Software Not Compatible Screen

10. If the screen in (Fig. 5) is displayed, the USB flash drive was not set up correctly. Use a top name brand USB flash drive, like Kingston, create a new USB flash drive and start the update again.

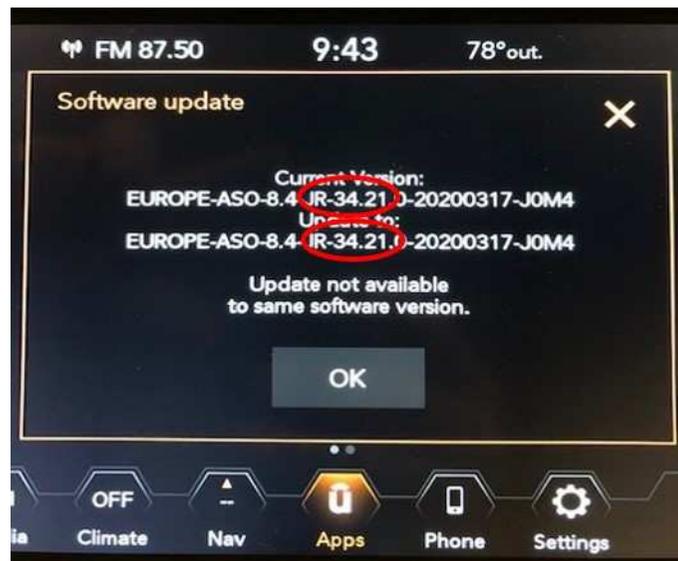
Fig. 6

Screen Displayed When Radio Software Level Is Up To Date

11. If the radio software is up to date, the screen in (Fig. 6) will be displayed. Press "OK" and remove the USB flash drive.

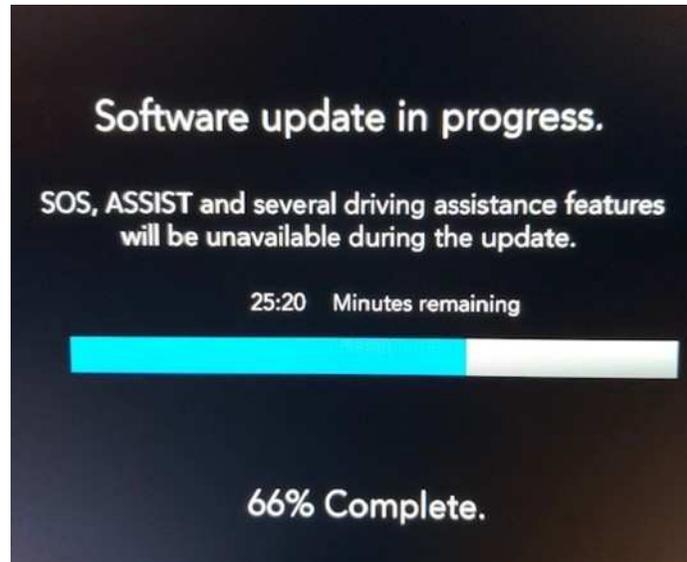
Fig. 9

Software Update In Progress

14. The radio will reboot and the update will begin. The update should only take 25 minutes, the timer on the screen may display the incorrect time remaining, (Fig. 9) .

NOTE: The completion indicator may not reach 100%, even though the software update has been completed. Once the software update has finished, the radio and display screen will turn off.

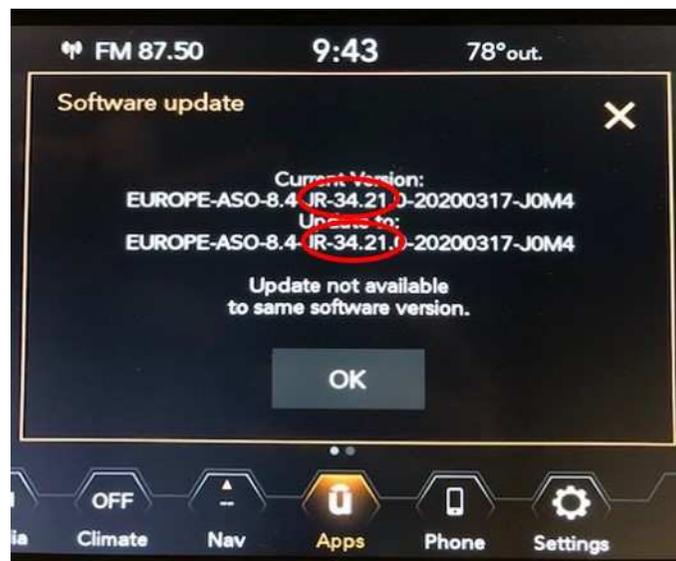
Fig. 10

Radio Software Has Been Updated

15. After the update has completed, the radio will shut down. With the USB flash drive still inserted in the USB port, cycle the ignition back to the run position. If the radio has been updated correctly, the screen in (Fig. 10) will be displayed. Press "OK" and remove the USB flash drive.
