**NUMBER:** 08-016-18 REV. A

**GROUP:** 08 - Electrical

RG3 RG4 RJ3 RJ4 Radio Enhancements

This bulletin involves inspecting and if required, updating the radio software.

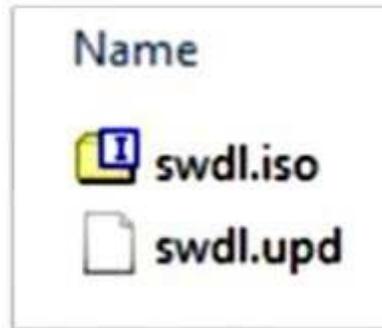
Fig. 1  
Two USB Files

**NOTE:** Two files will be loaded onto the USB flash drive (Fig. 1) .

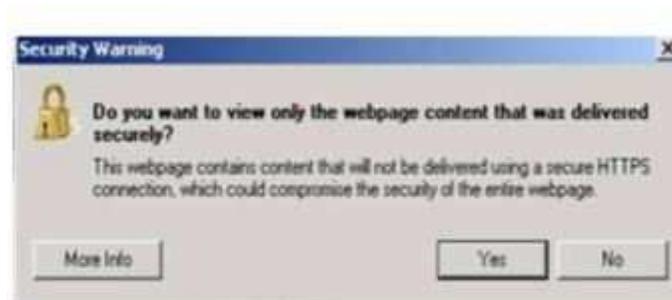
Fig. 2  
Pop-up Security Message

1. Has a USB flash drive been created?
  - YES >>> Proceed to [Step 5](#).
  - NO >>> Proceed to [Step 2](#).
2. Go to DealerCONNECT> Service> Uconnect Information & Utilities> Uconnect Dealer software downloads to download the files.
3. If a security message appears "Do you want to view only the web page content that was delivered securely?" (Fig. 2) Press No to continue.

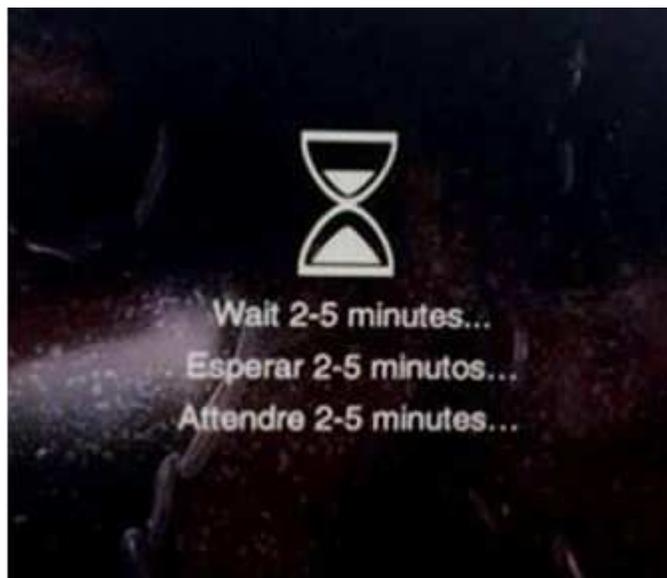
**Fig. 3  
Hourglass Screen**

**NOTE: During the update process you will see multiple hourglass and “Please Insert Update USB” screens for extended periods of time (several minutes) (Fig. 3) or (Fig. 4) . DO NOT remove the USB flash drive at this time. Only remove the USB flash drive when the update has completed, when the screen displays the software levels again. The screen will say “Software updated successfully”.**

**NOTE: During the update process, the screen on the radio will display an hourglass and blue screen that said "Please Insert Update USB" for approximately two to five minutes at a time ([Fig. 3](#)) and ([Fig. 4](#)).**

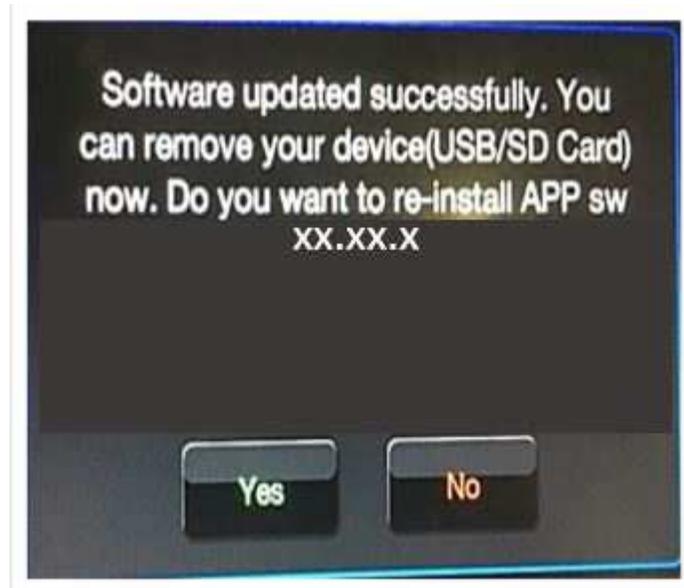
Fig. 5  
Software Updated Successfully

10. After the update is done, the screen will display the software levels again and will prompt the technician to remove USB flash drive, see (Fig. 5) .
