**NUMBER:** 08-094-17

**GROUP:** 08 - Electrical

**DATE:** September 28, 2017

RG3 RG4 RJ3 RJ4 Radio Enhancements

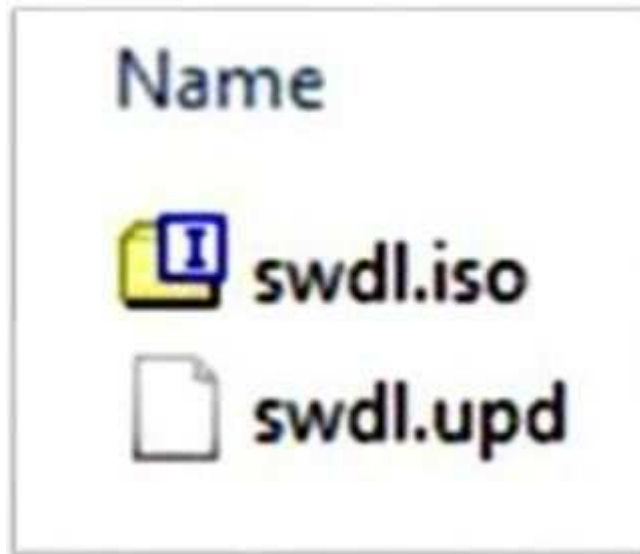
**Fig. 1**  
**Two USB Files**

**NOTE: \*\*Two files will be loaded onto the USB flash drive (Fig. 1) .**

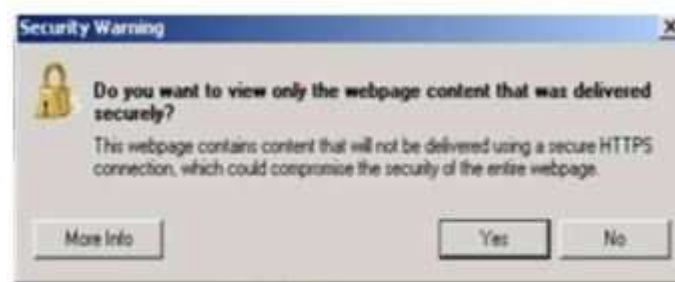
**Fig. 2**  
**Pop-up Security Message**

1. Has a USB flash drive been created?
  - a. YES >>> Proceed to [Step 5](#).
  - b. NO >>> Proceed to [Step 2](#).
2. Go to DealerCONNECT> Service> Uconnect Information & Utilities> Uconnect Dealer software downloads to download the files.
3. If a security message appears “Do you want to view only the web page content that was delivered securely? (Fig. 2) Press No to continue.

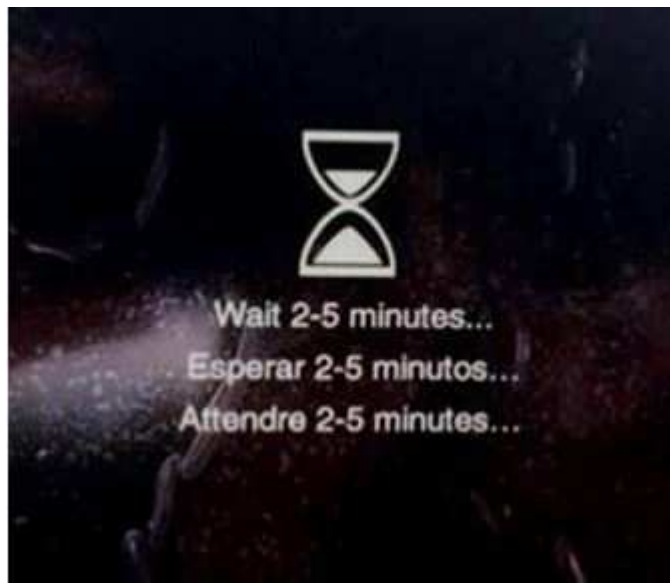
Fig. 3  
Hourglass Screen

**NOTE:** During the update process you will see multiple hourglass and “Please Insert Update USB” screens for extended periods of time (several minutes)(Fig. 3) or (Fig. 4) . DO NOT remove the USB flash drive at this time. Only remove the USB flash drive when the update has completed, when the screen displays the software levels again. The screen will say “Software updated successfully”.

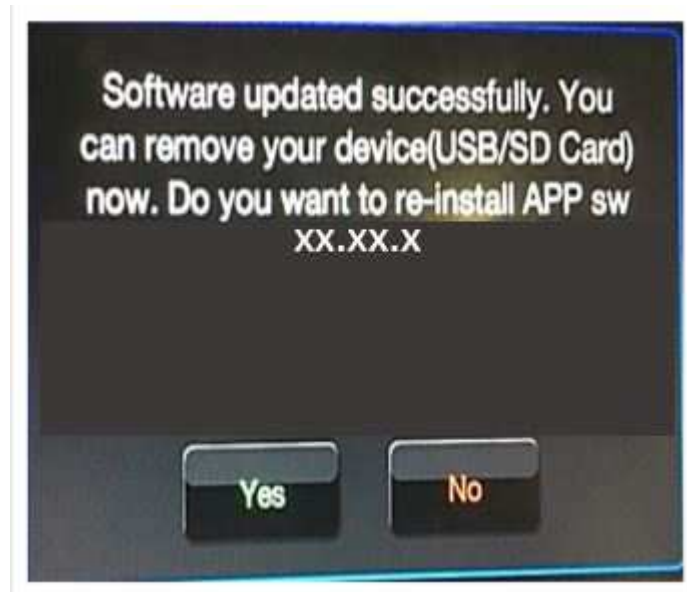
Fig. 5  
Software Updated Successfully

12. After the update is done the screen will display the software levels again and will prompt to remove USB (Fig. 5) .
