# SERVICE BULLETIN

**NUMBER:** 08-035-18 REV. A

RJ3 RJ4 RG3 and RG4 Radio Enhancements

This bulletin involves inspecting and updating the radio software, if required.

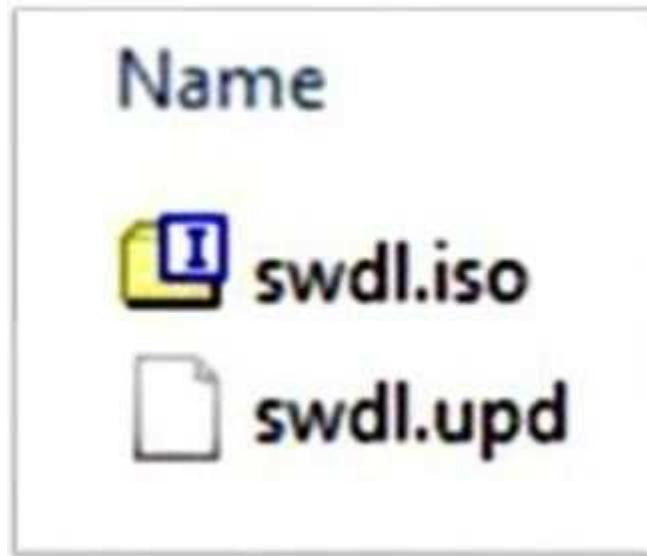
**Fig. 1**  
**Two USB Files**

**NOTE: Two files will be loaded onto the USB flash drive ([Fig. 1](#)).**

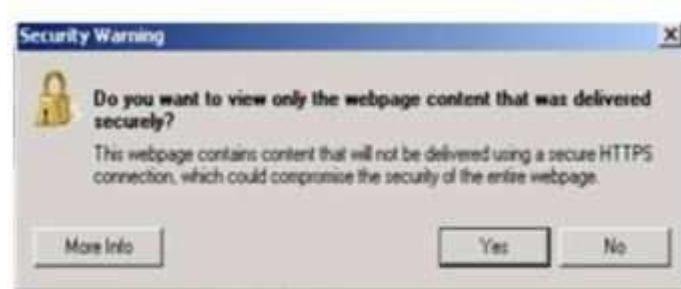
**Fig. 2**  
**Pop-up Security Message**

3. If a security message appears “Do you want to view only the web page content that was delivered securely?” (Fig. 2) . Press “No” to continue.

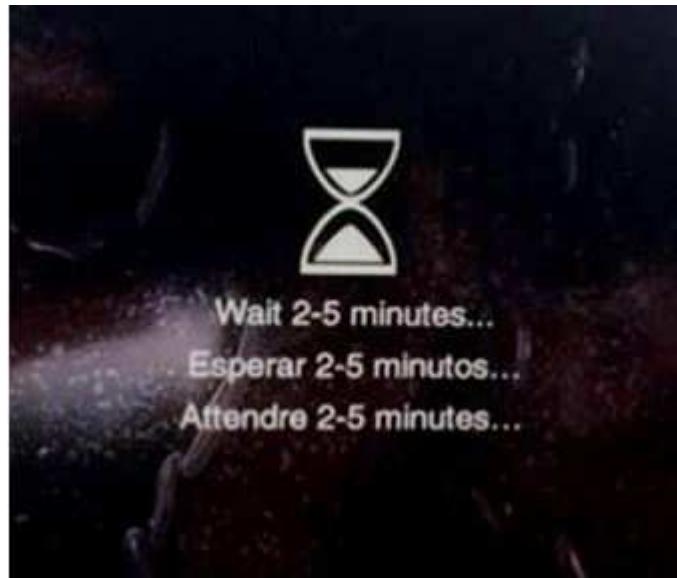
Fig. 3  
Hourglass Screen

**NOTE: During the update process you will see multiple hourglass and “Please Insert Update USB” screens for extended periods of time (several minutes) (Fig. 3) or (Fig. 4) . DO NOT remove the USB flash drive at this time. Only remove the USB flash drive when the update has completed, when the screen displays the software levels again. The screen will say “Software updated successfully”.**

**NOTE: During the update process, the screen on the radio will display an hourglass and blue screen that say "Please Insert Update USB" for approximately two to five minutes at a time ([Fig. 3](#)) and ([Fig. 4](#)).**

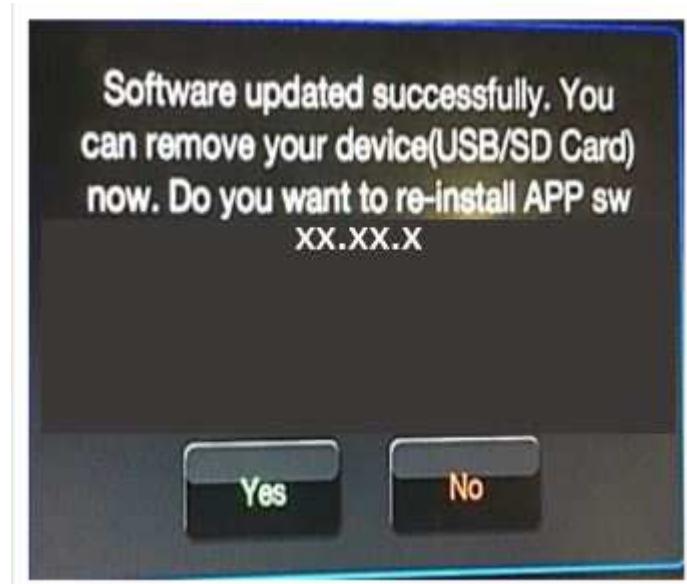
**Fig. 5  
Software Updated Successfully**

10. After the update is done, the screen will display the software levels again and will prompt to remove USB ([Fig. 5](#)).
